# Creative Habitat Corp.

Ecological Consultants with special  
expertise in restoration and bioengineering

Presented at Brookhaven National  
Laboratory,

December 12, 2000

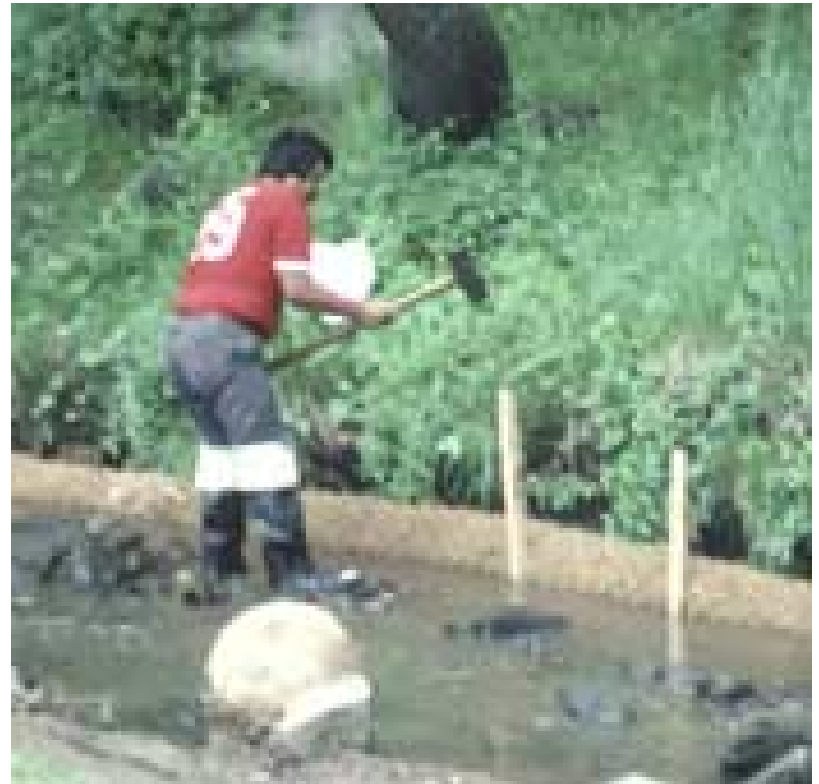
- Creative Habitat Corp. was the first company to introduce coconut fiber based logs for stabilization of stream banks in the USA.

Shown here a typical installation of the “log” along a small stream.

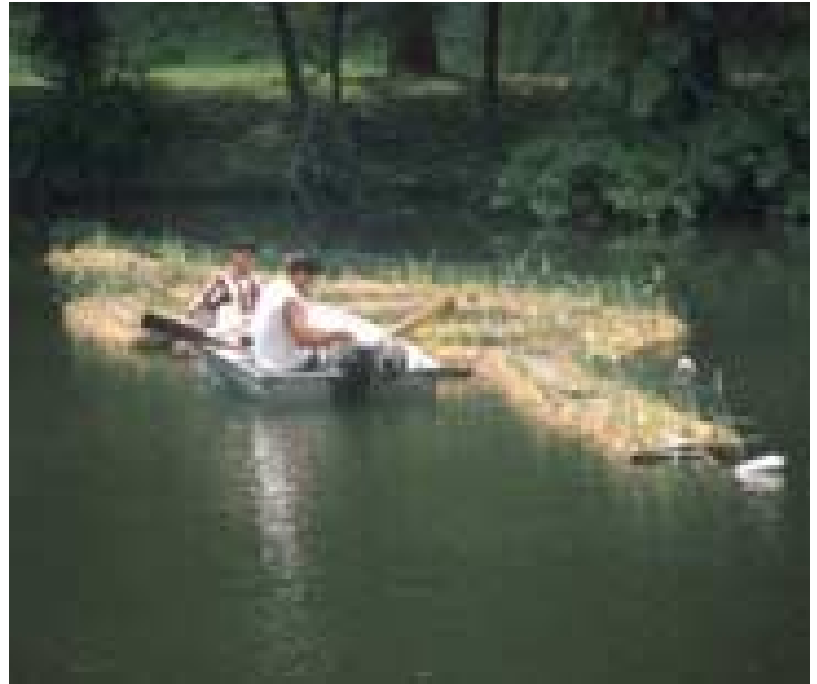
- CHC currently pioneers the use of floating planted habitat islands for water quality improvements where shore frontage cannot be used to establish filter beds.

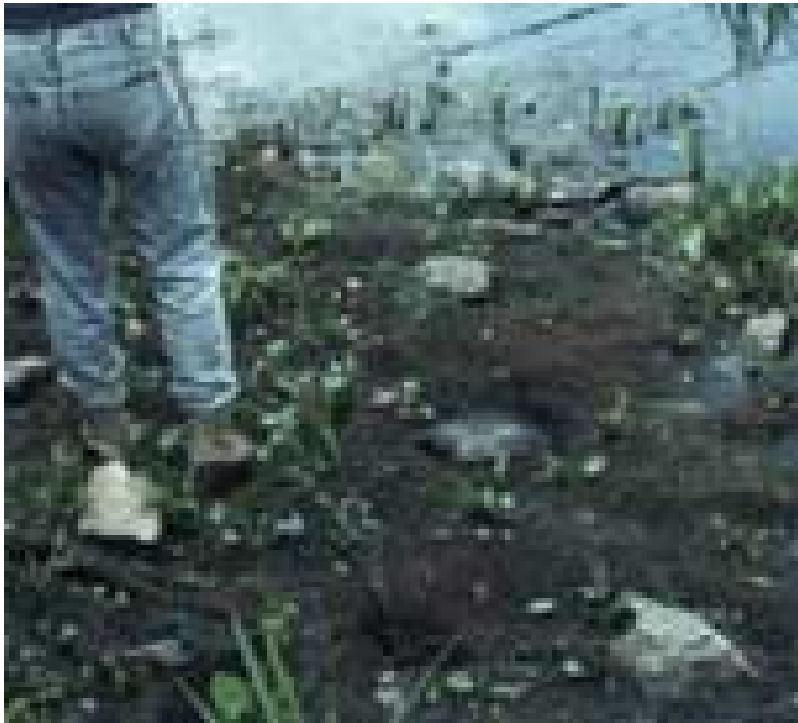
- Unconsolidated “mud” can be very expensive to excavate. Where site conditions permit we are able to use native plants to “cover” and contain problem soils. Prior to treatment the person shown would have sunk knee deep into “mud”.

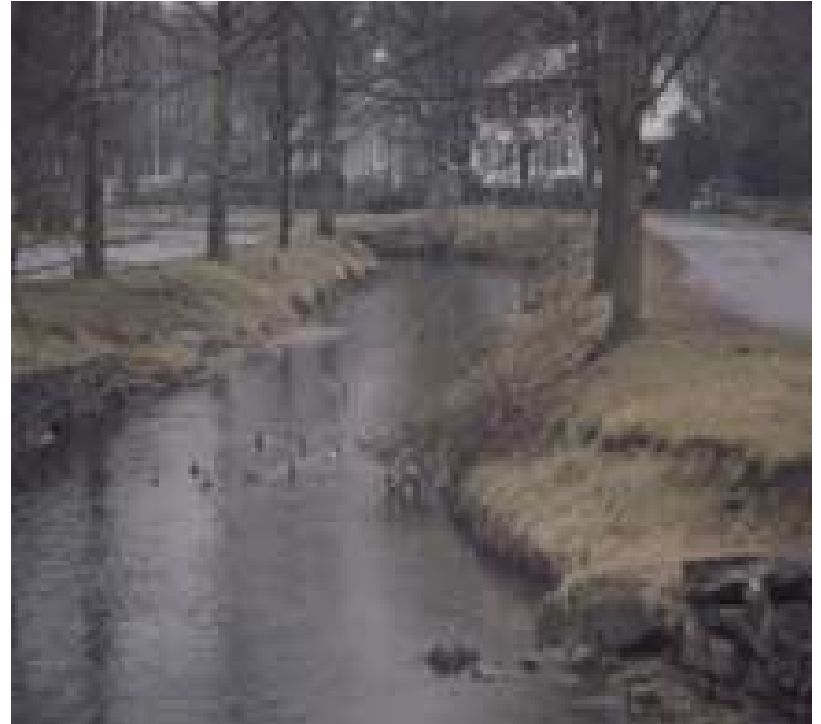
- Bank erosion along this seemingly placid stream was in the past addressed by the building of stone walls (seen in foreground on right).

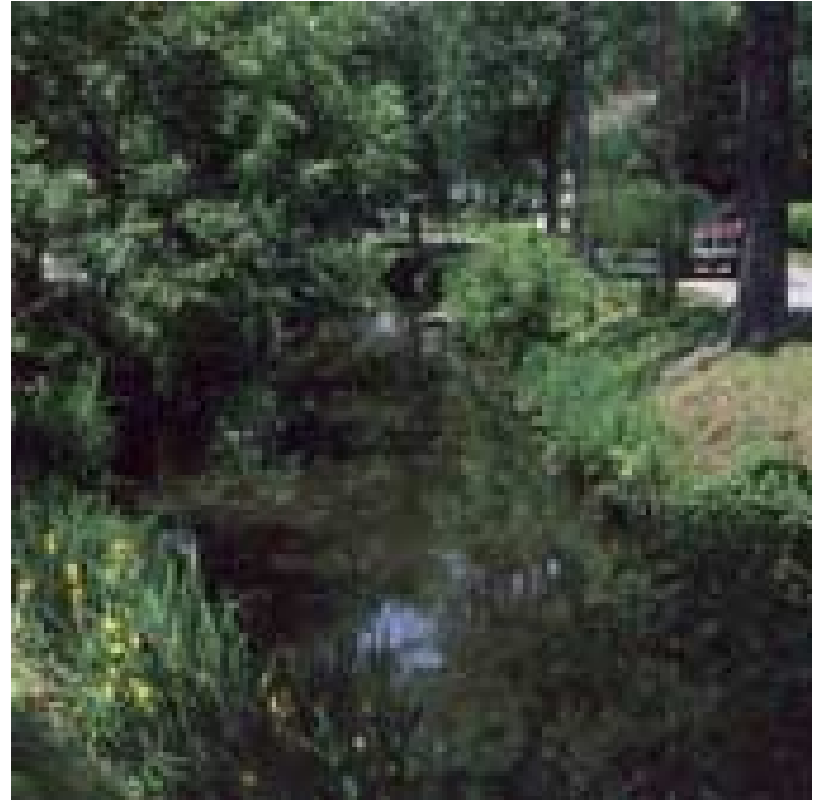
- The project owner opted for significant cost savings, ecological improvements and an esthetic upgrade, which was favorably commented on by the many frequent users of this public space. Photo approximately two years after installation.

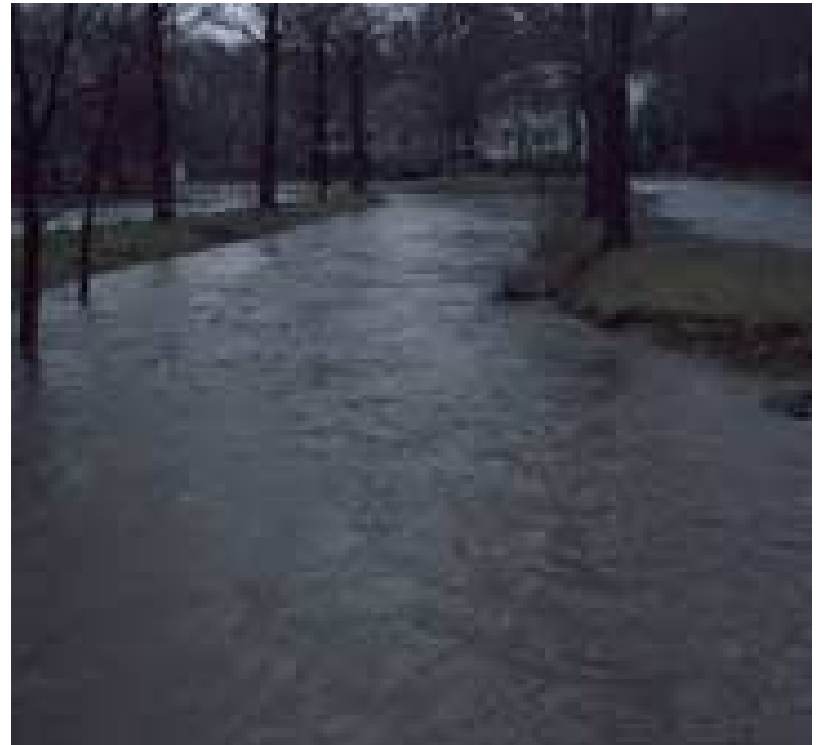
- Located downstream from a flood control reservoir, the river turns into a raging torrent from time to time, without inflicting damage to the erosion control plantings.

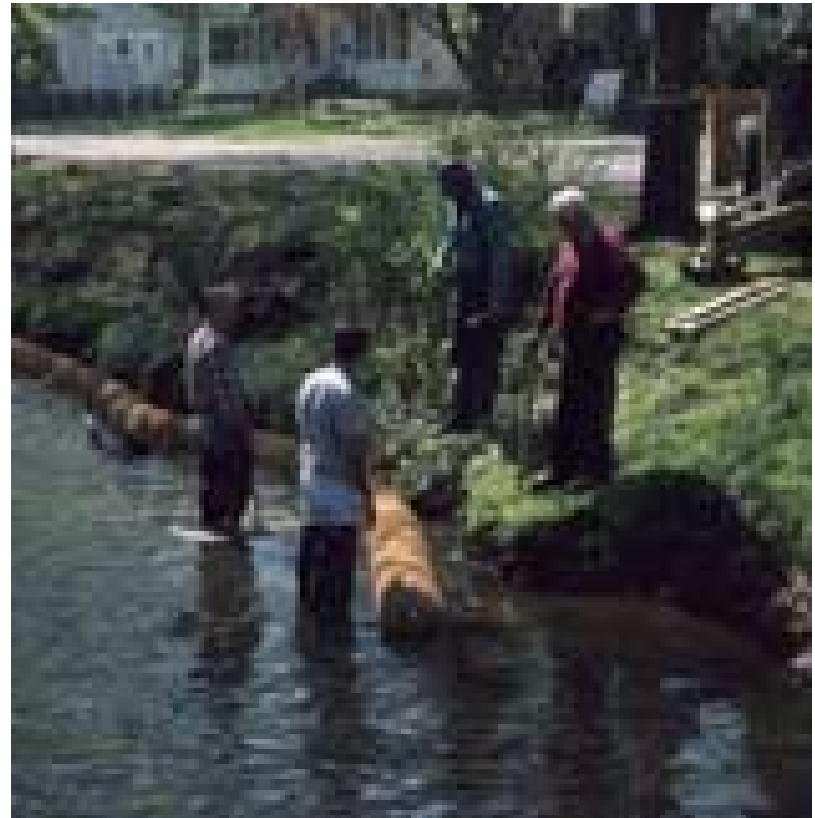
- The work was installed by municipal labor, under guidance from Creative Habitat, adding to the cost savings and providing an unusual and well liked project for the work force.

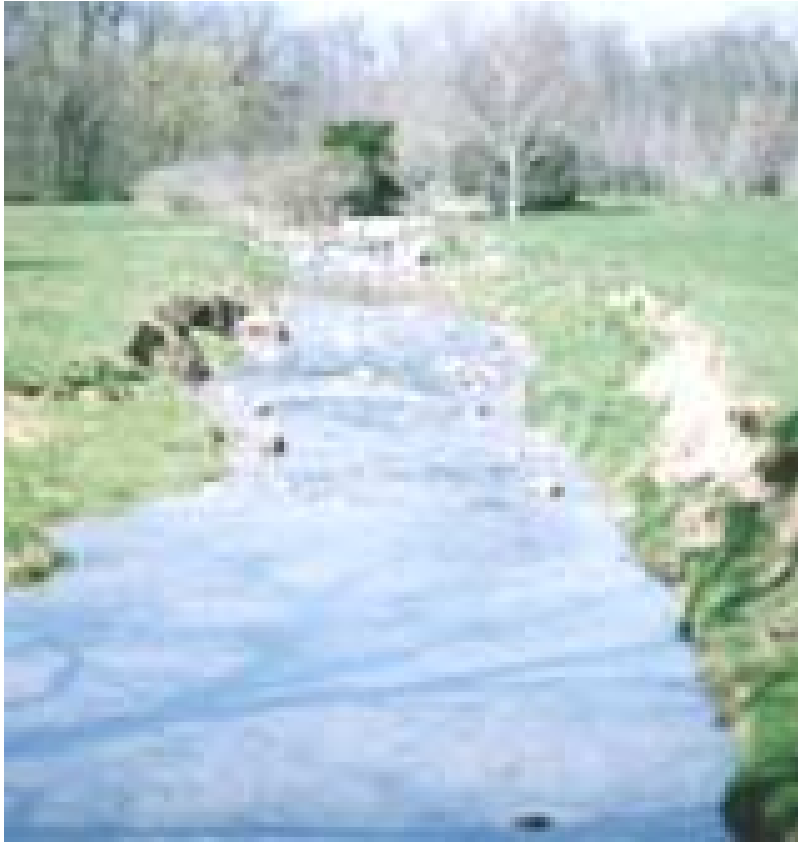
- Photo 1990, prior to stream bank repair and stabilization work. This stream just outside urban Allentown, PA, is the recipient of storm water discharges from a 5 square mile area. An energy dissipater (concrete barrier with vertical slots) at the outfall of a storm sewer is visible in the upper middle.

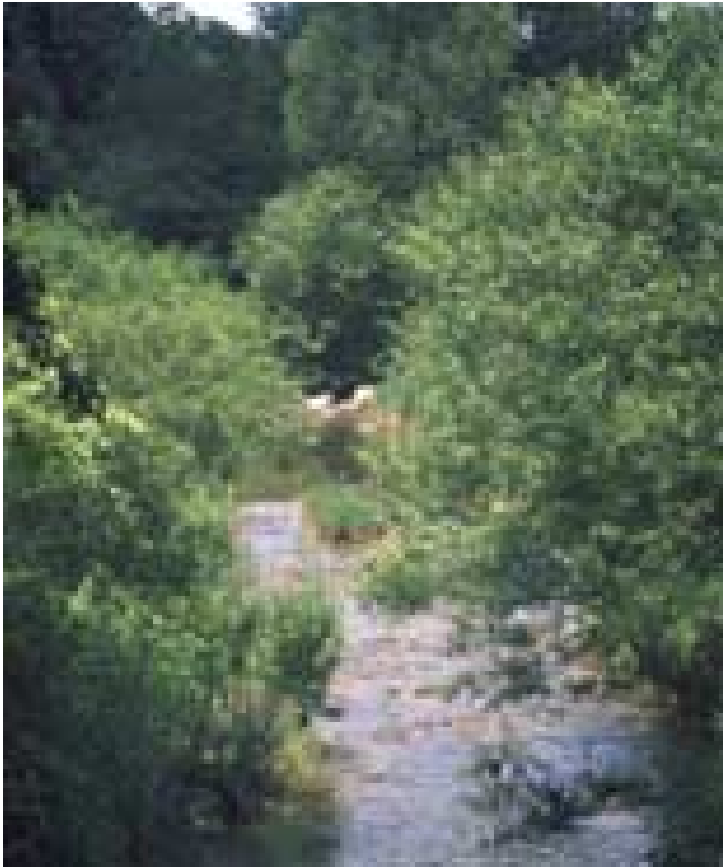
- Seven years after stabilization work this stream is almost unrecognizable. The plantings survived a 100-year storm event with velocities of more than 20 f/s only months after the initial installation.

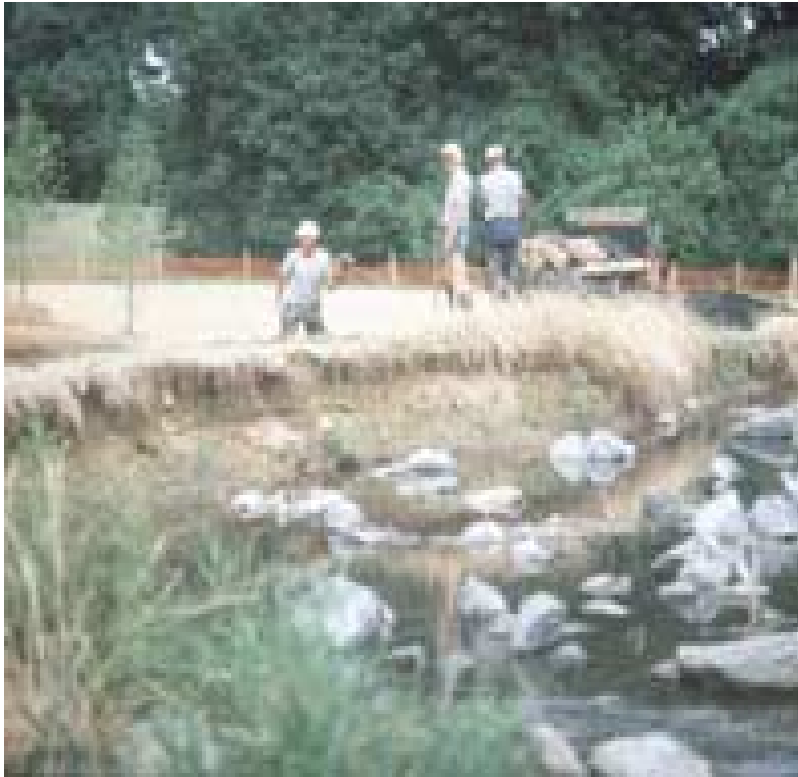
- The same stream, only here a whirlpool was continually eroding the embankments. Stone in foreground serve to roughen the streambed and are part of the restoration strategy.

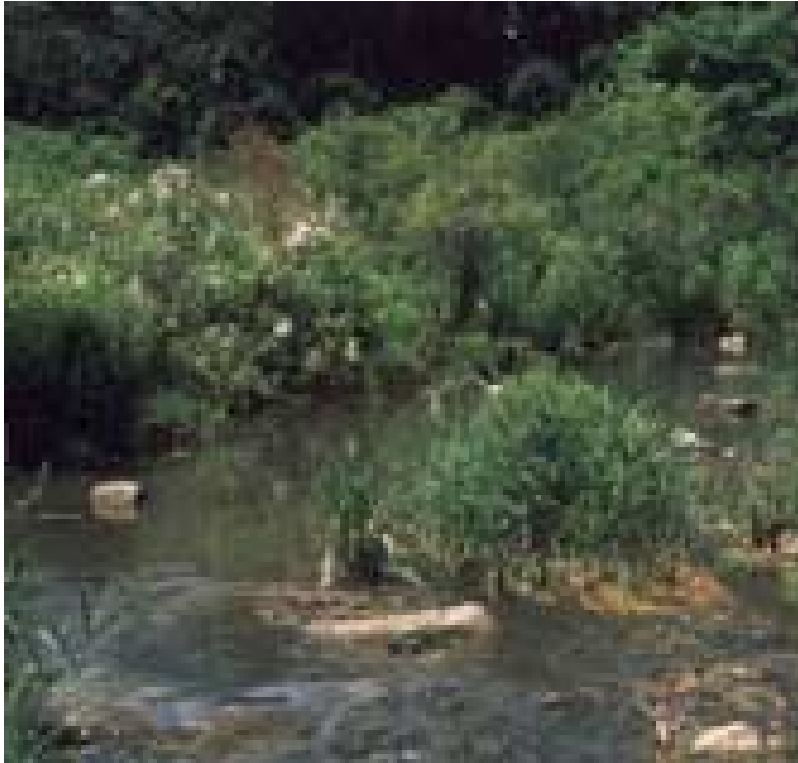
- This photo was taken seven years after the stabilization work was done. However even one year after the planting the site had looked very similar.

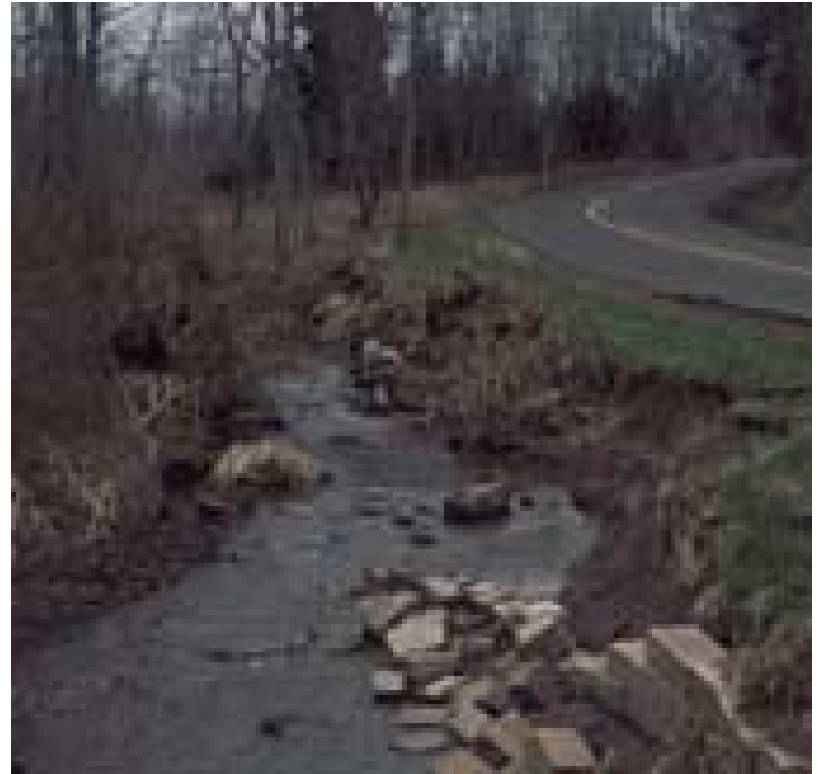
- An unnamed small tributary to Fretz Valley Stream , Bucks County, PA, was beginning to undermine a local road and bridge abutments.

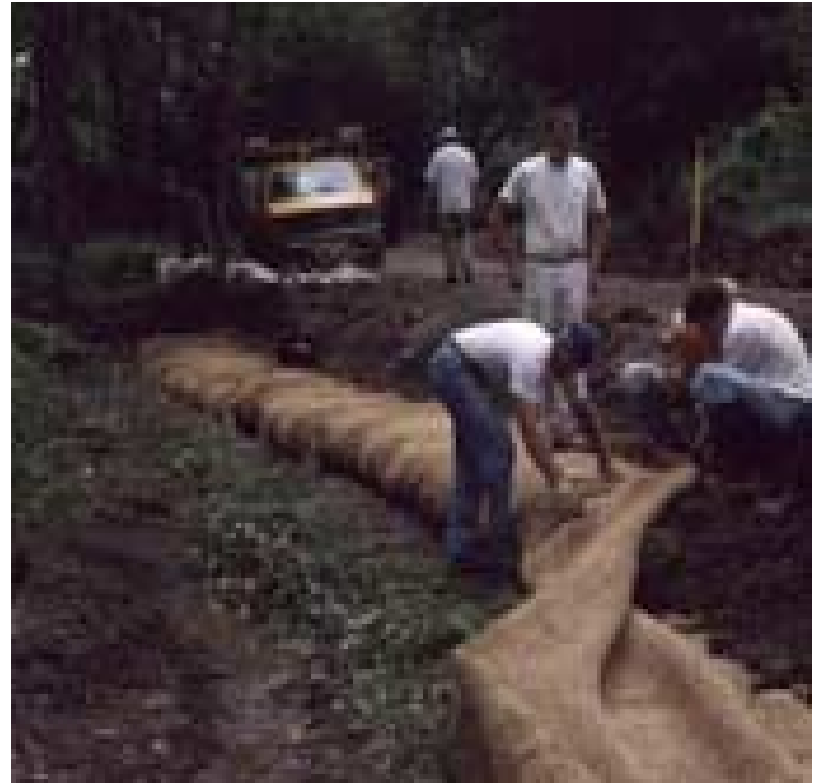
- Creative Habitat instructed crews of Pennsylvania DOT in the use of traditional brush layering techniques with willow cuttings and erosion control mats.

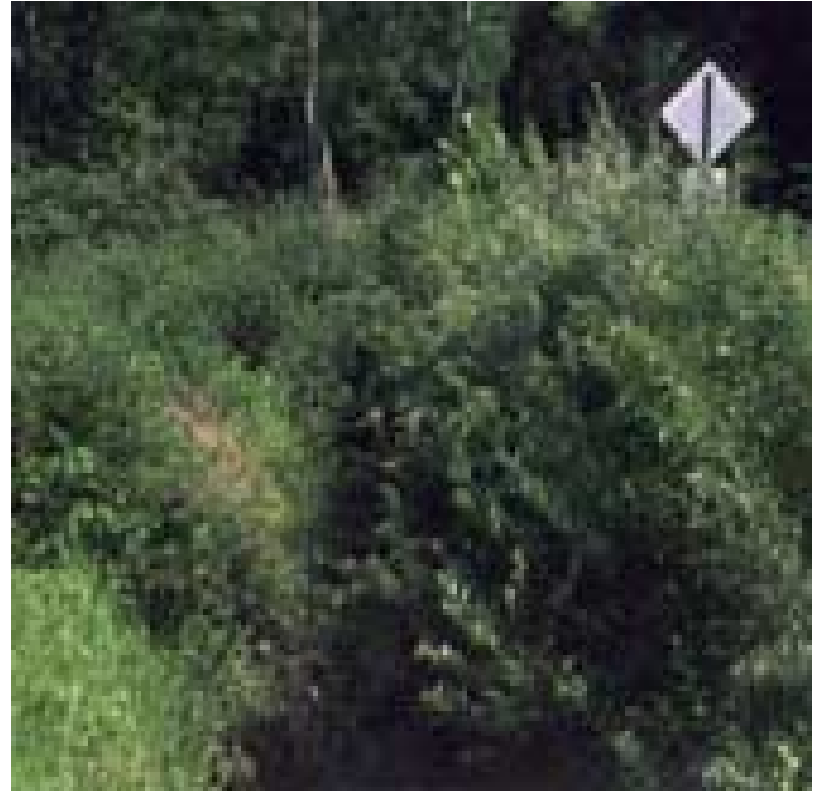
- Two years later the willows had grown 6 feet tall and the road embankment was fully stabilized.

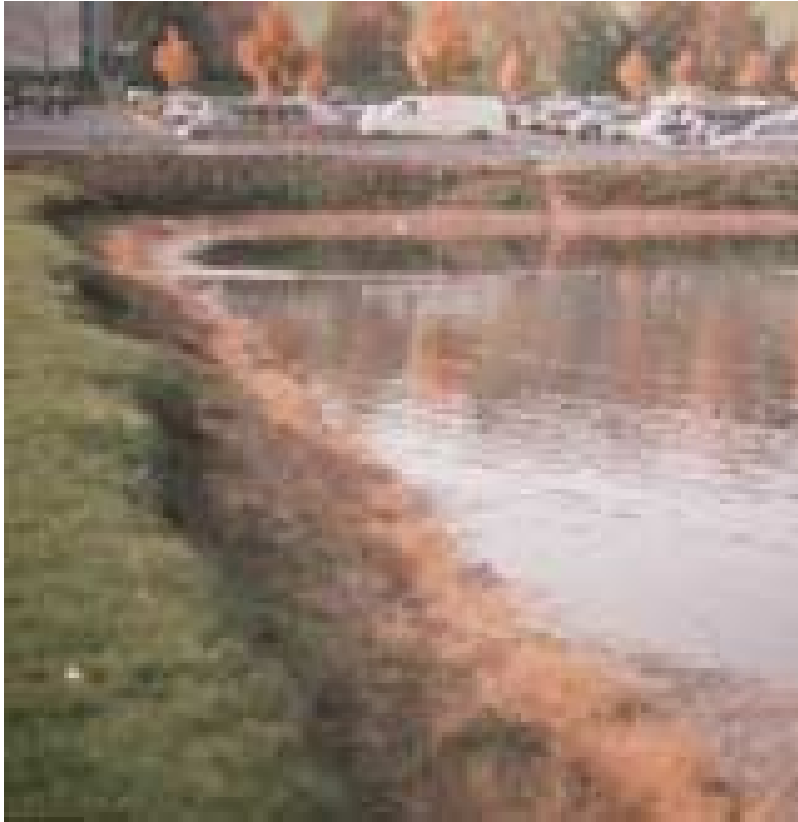
- Located in eastern PA, this corporate park was investing a significant amount of money to line this leaky fire pond. Creative Habitat's expertise was sought to prevent a return of this edge erosion after the work was done.

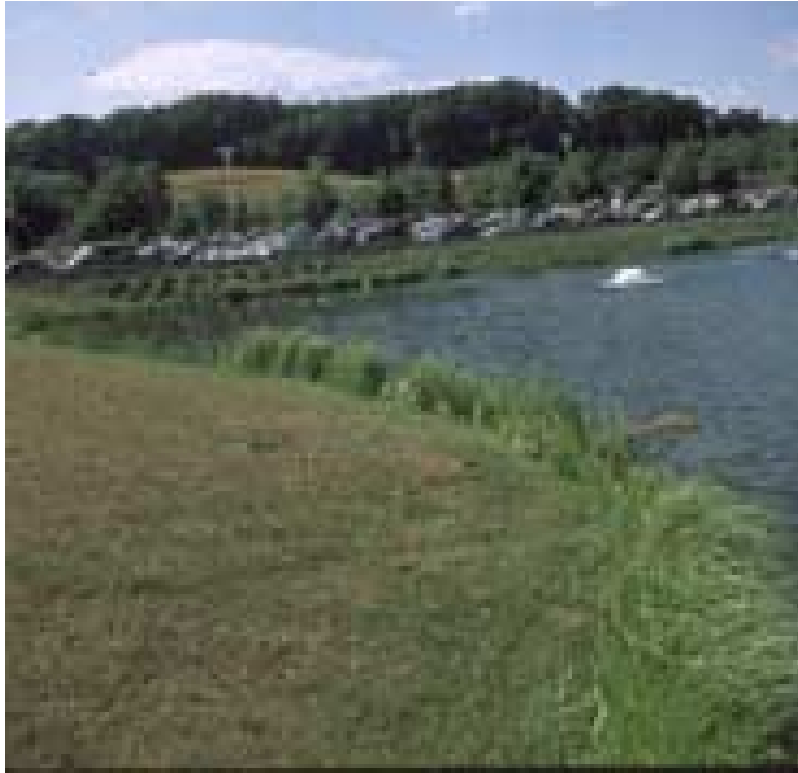
- We combined targeted plant selection and an edge treatment with coconut fiber based bioengineering products to create this narrow stable edge of “natural habitat”.

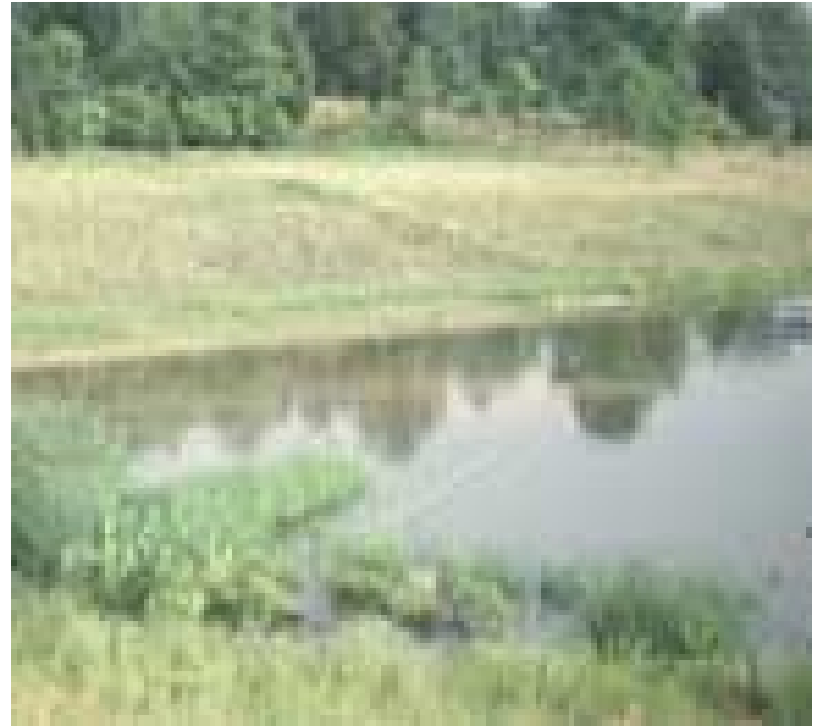
- Shown in the foreground is a demonstration planting of emergent wetland plants on herbivory resistant starter sods. Unplanted barren shore in background.

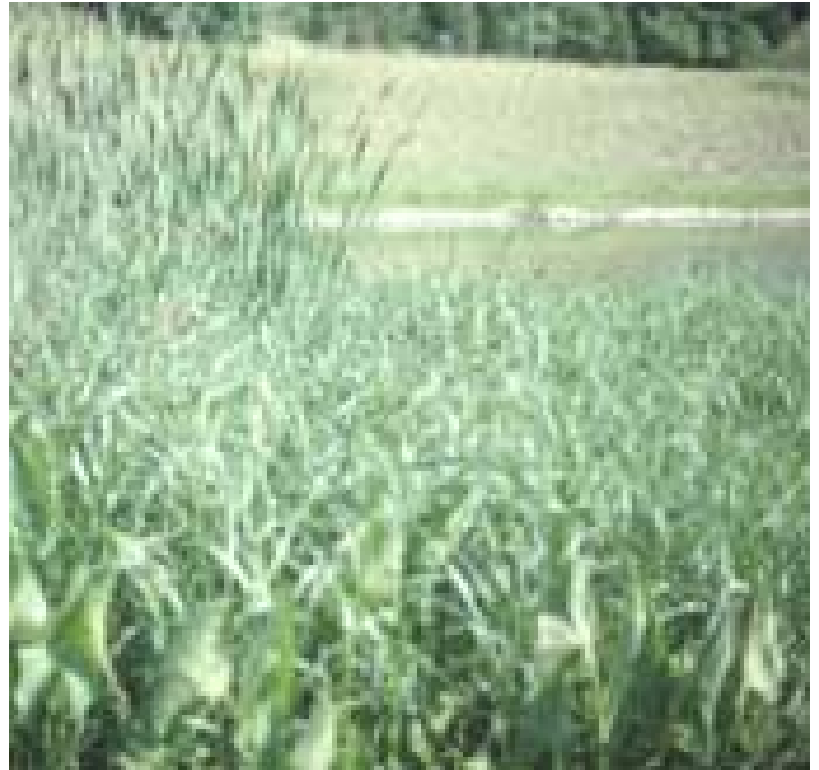
- One year later the demonstration planting had spread into a functional marsh which acted as a magnet for diverse wildlife, including a muskrat, several Canada Geese, Redwing Blackbird, amphibians and fish.

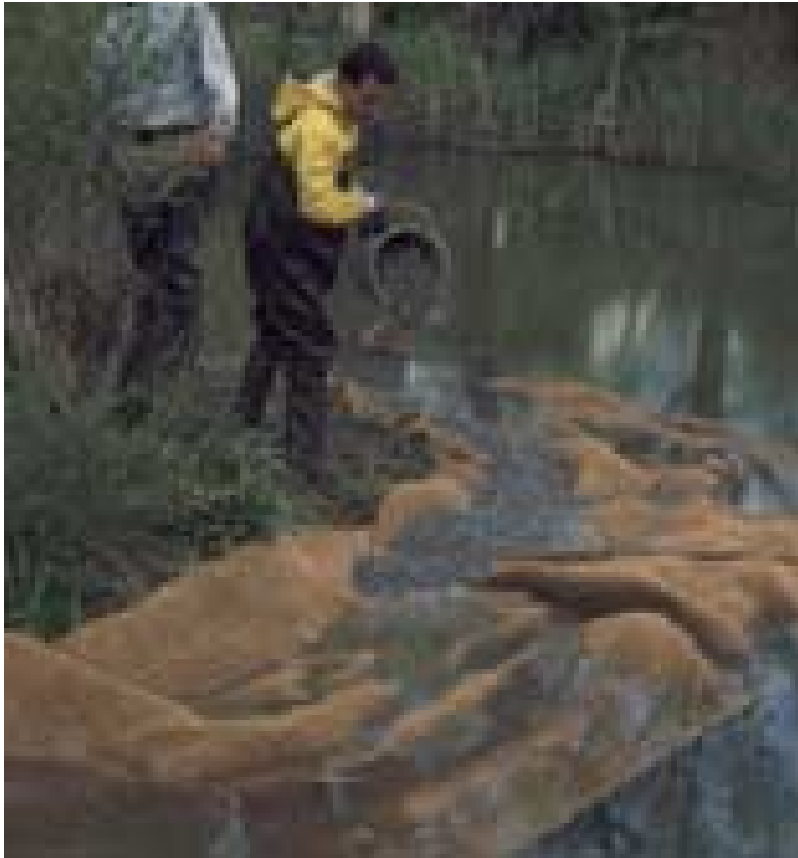
- In a setting where birds are kept captive on limited space they are prone to destroy plantings as a means to fight against boredom. New plantings require safe footings.

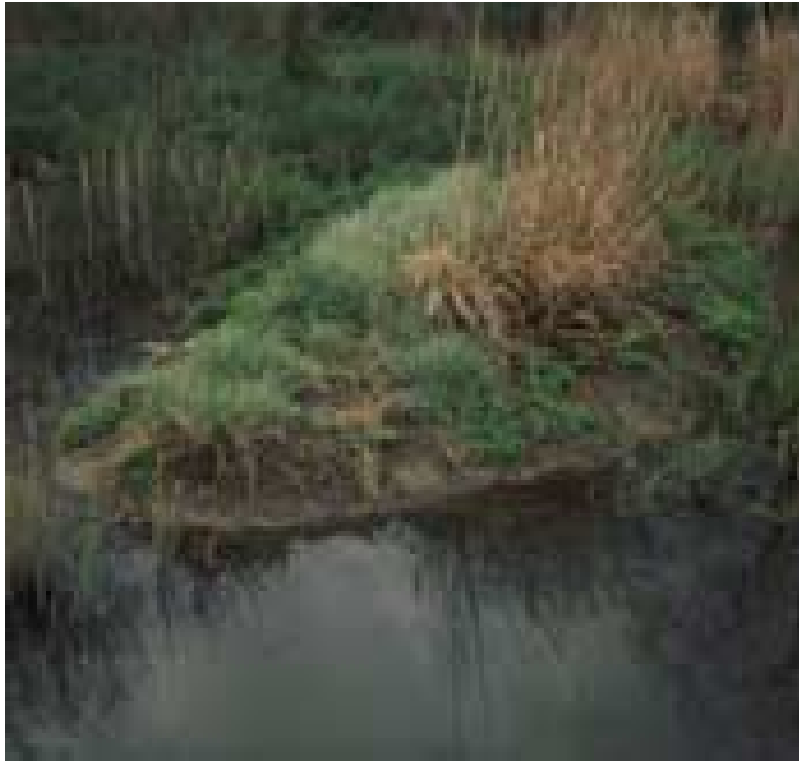
- This little island may serve as an example of the importance of proper plant selection and anchoring. Here shown before planting.

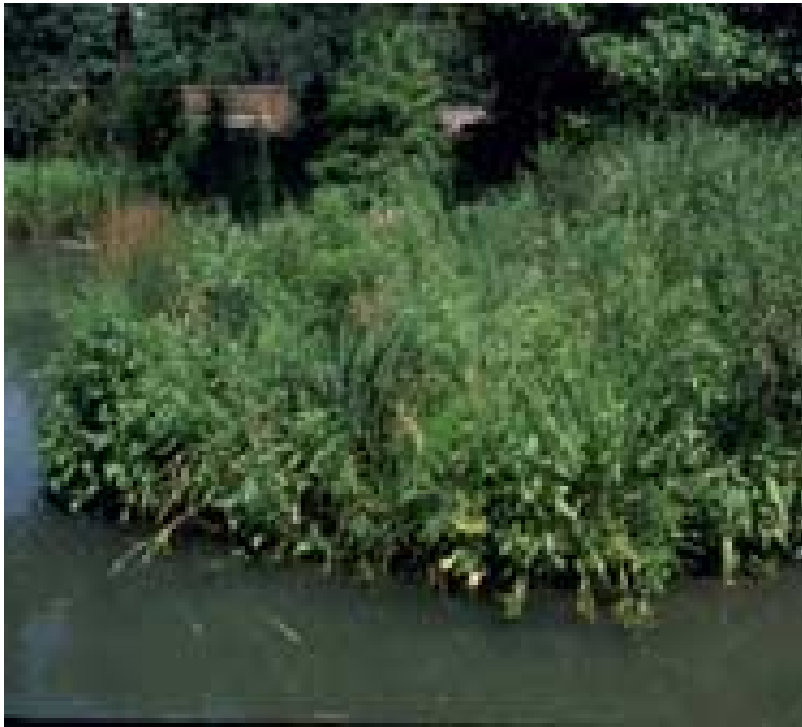
- One year later the same island brims with fresh green herbaceous growth while serving as the permanent home for a couple of swans – known to be even more destructive than Canada Geese.

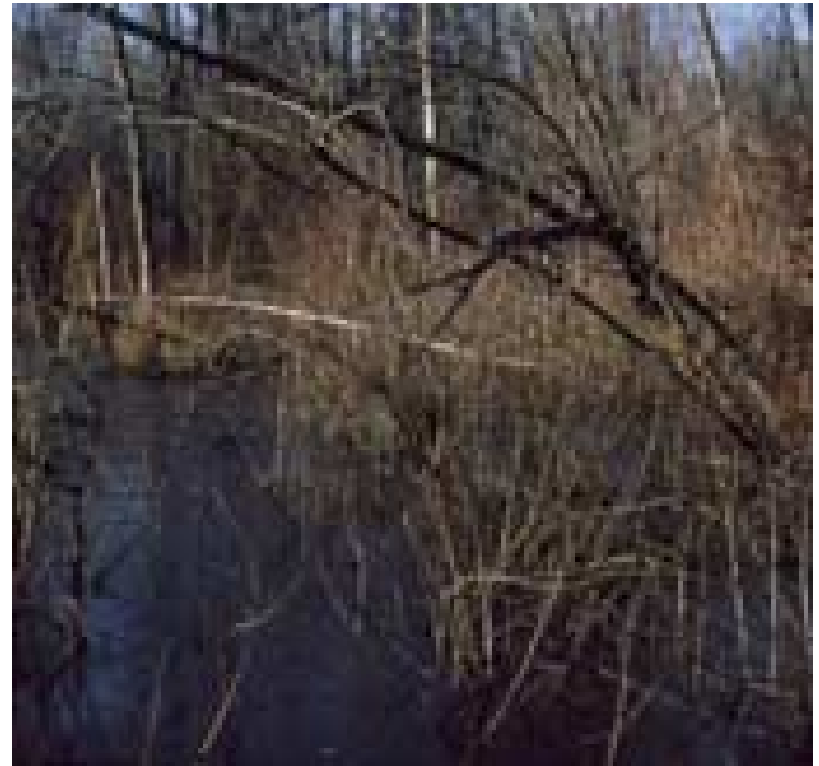
- This typical habitat of the New York state threatened Blanding's Turtle was our design target. Creative Habitat was part of a team of scientists and engineers who were striving to recreate this type of habitat instantaneously to provide uninterrupted habitat as part of a permit condition for construction.

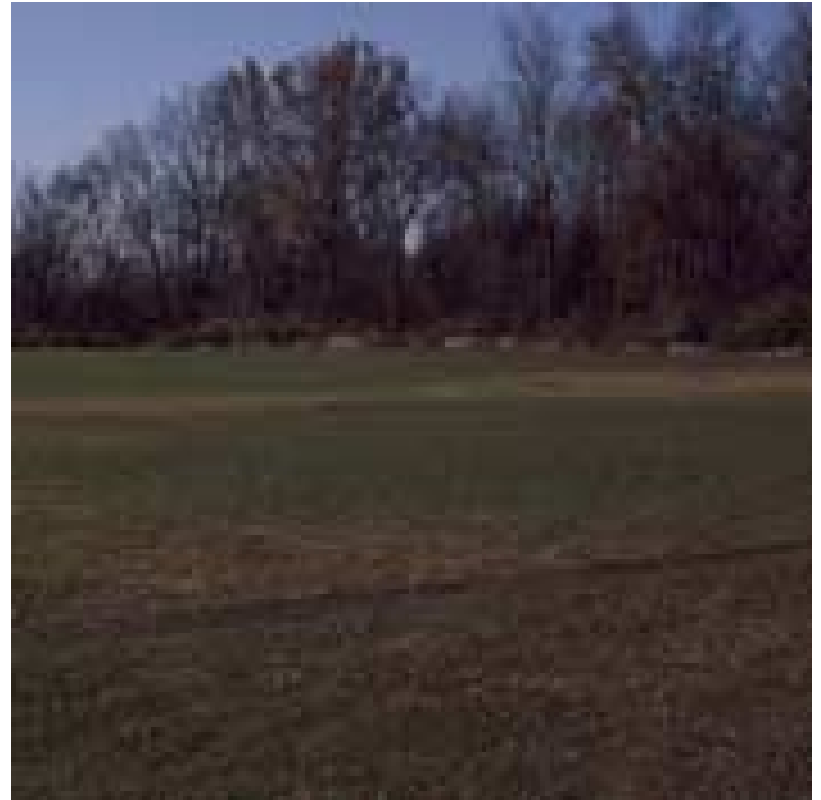
- The only site available for the creation of this wooded wetland was a former ball field. Excavation of this area provided a receptor site for suitable plant material.

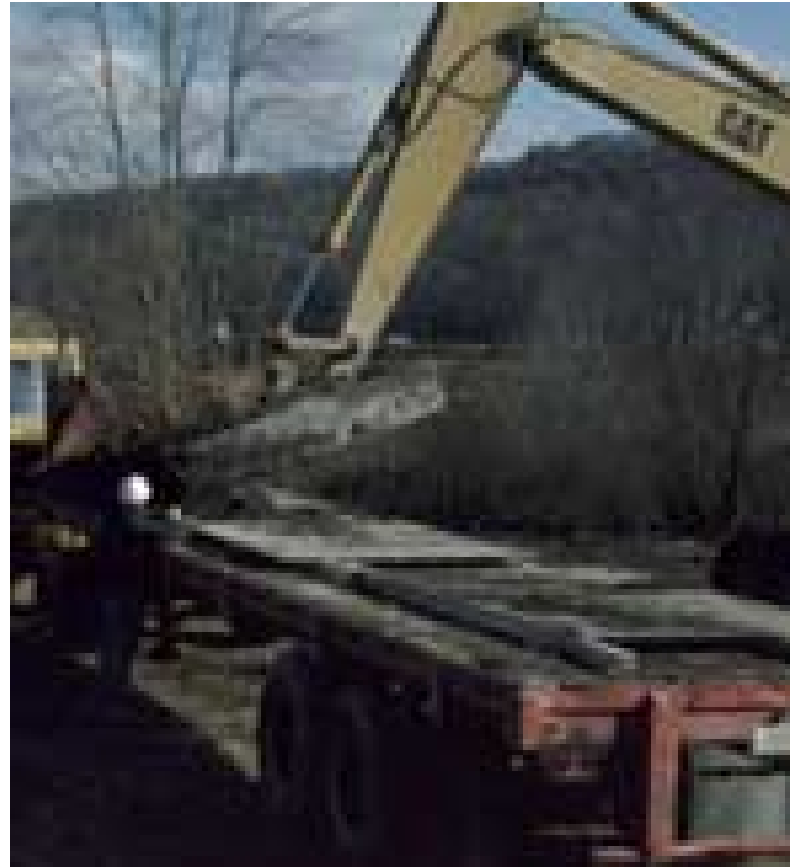
- Instead of allowing an existing small wetland to be filled in all salvageable soils and plants were removed into the receptor site.

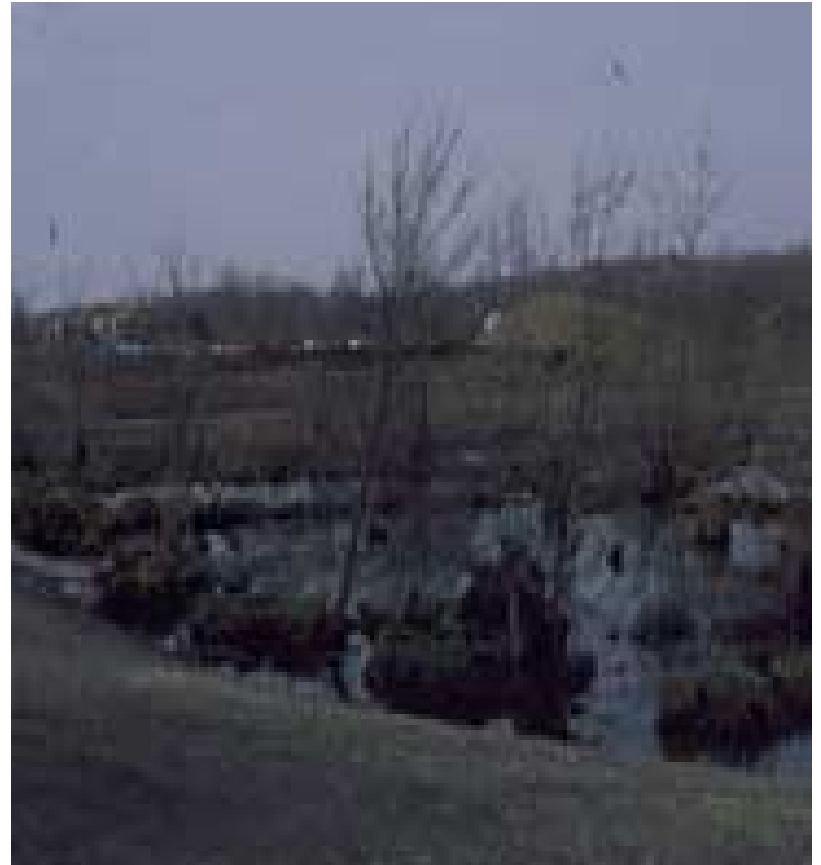
- The work was started in November; by March the new wetlands were in place.

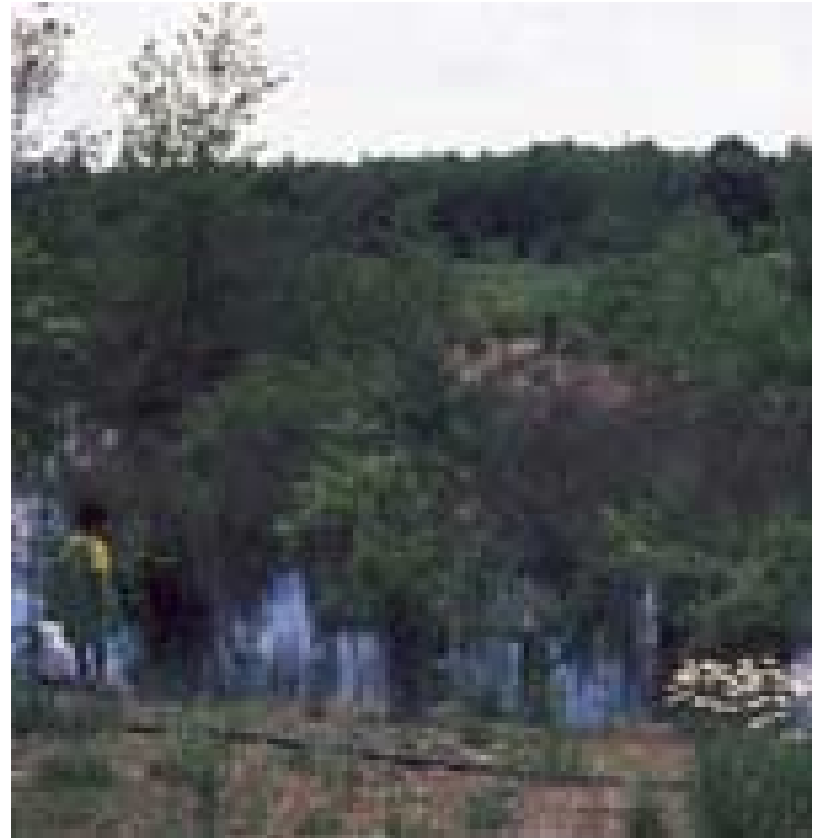
- Although the site as shown here was only in it's first season it was already functional and structurally similar to our design model. The site has subsequently been proven to be attractive as habitat for the Blanding's turtle. Standing left in foreground an adult person.

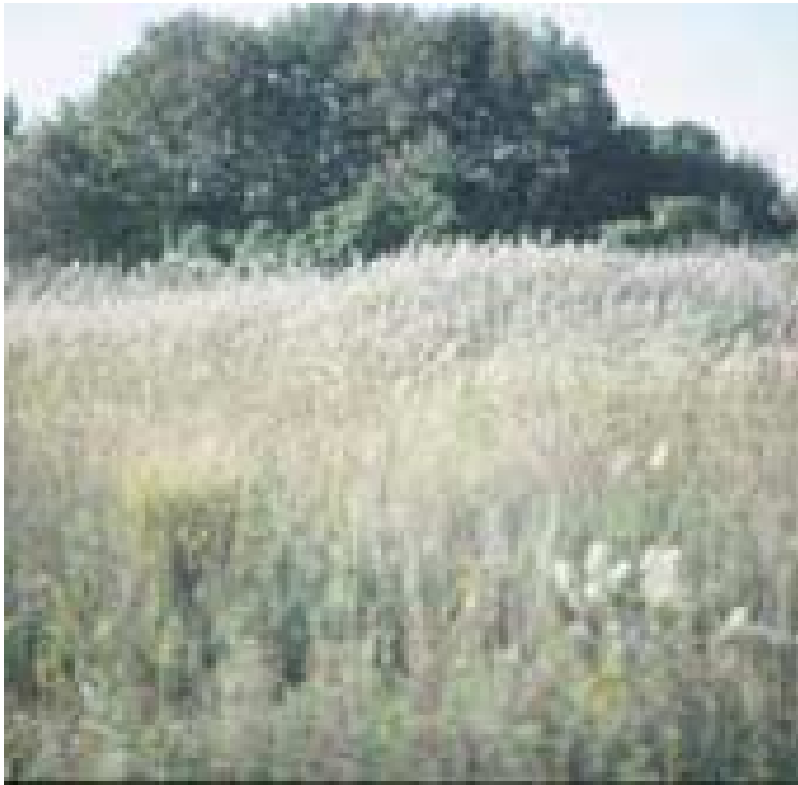
- This former construction staging area had developed into an expanse of Phragmites and miscellaneous “weeds”. Creative Habitat was commissioned to turn it into coastal grassland.

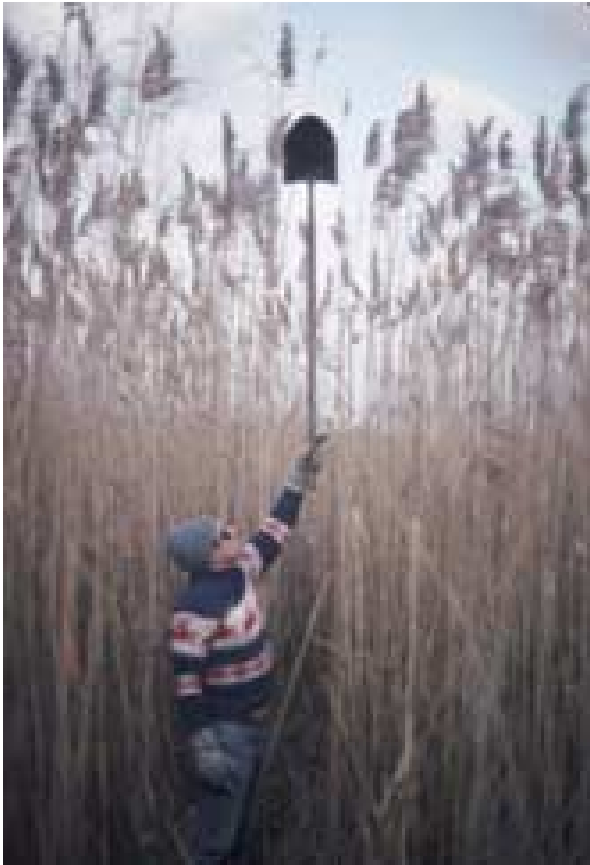
- In portions of the site Phragmites culms grew 12 to 15 feet tall.

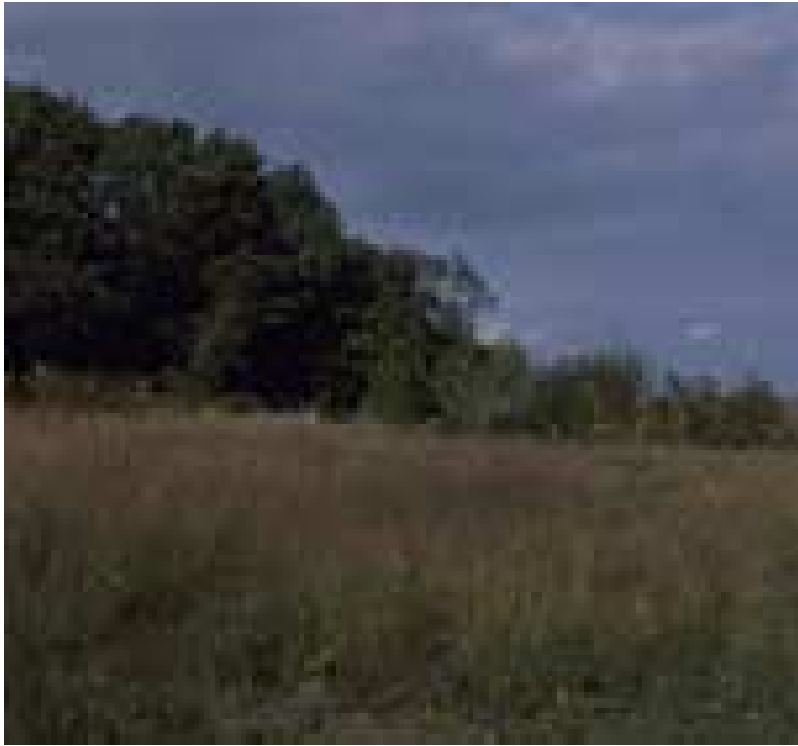
- Two years after restoration work was begun (as shown in this photo), the site shows no signs of a return of *Phragmites*. In the year 2000 the site was in its fourth year and was very stable.

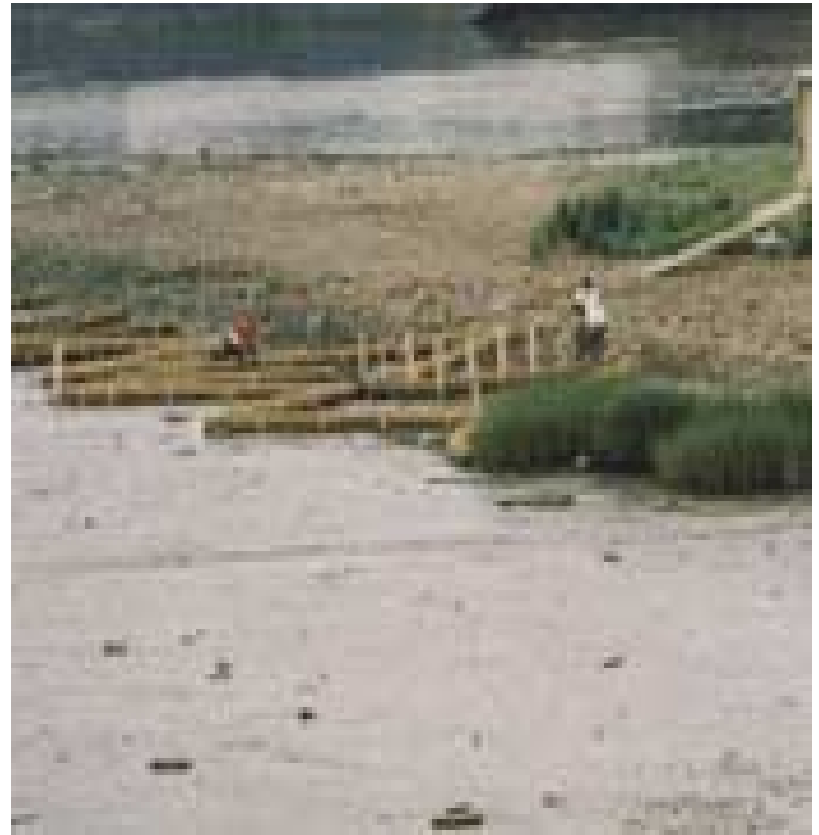
- Using breakwater structures to dampen wave energy Creative Habitat reconnected remnants of salt marsh. In background barren ground was not regenerating plant growth due to excessive wave energy.

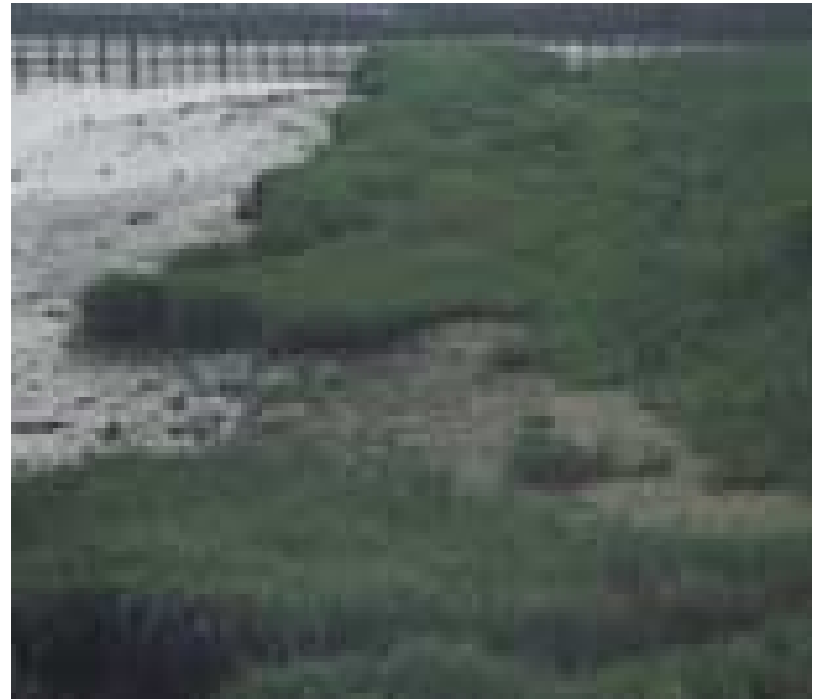
- Three years later not only had the planting been a success but it had also resulted in the voluntary recruitment of salt marsh in the now protected zone further upland. In front an area that had not received a restoration treatment.

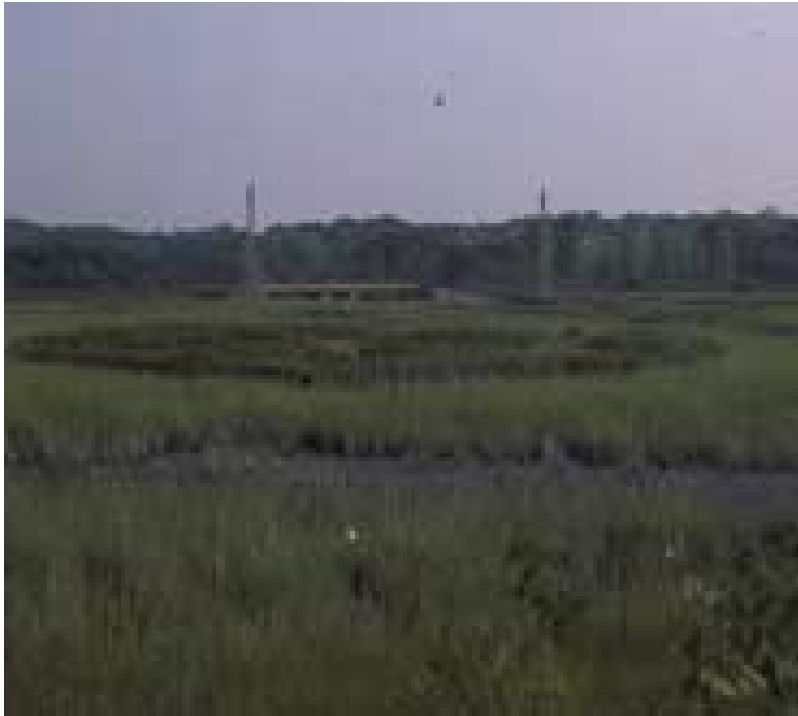
- Alley Pond Marsh, Queens, NY, was restored under the guidance of Creative Habitat. We are currently monitoring the success of the project for five years.
